Field Evaluation of Alternative Isolation Joints at O'Hare

ARMEN AMIRKHANIAN (PRESENTING)

UNIVERSITY OF ILLINOIS URBANA-
CHAMPAIGN

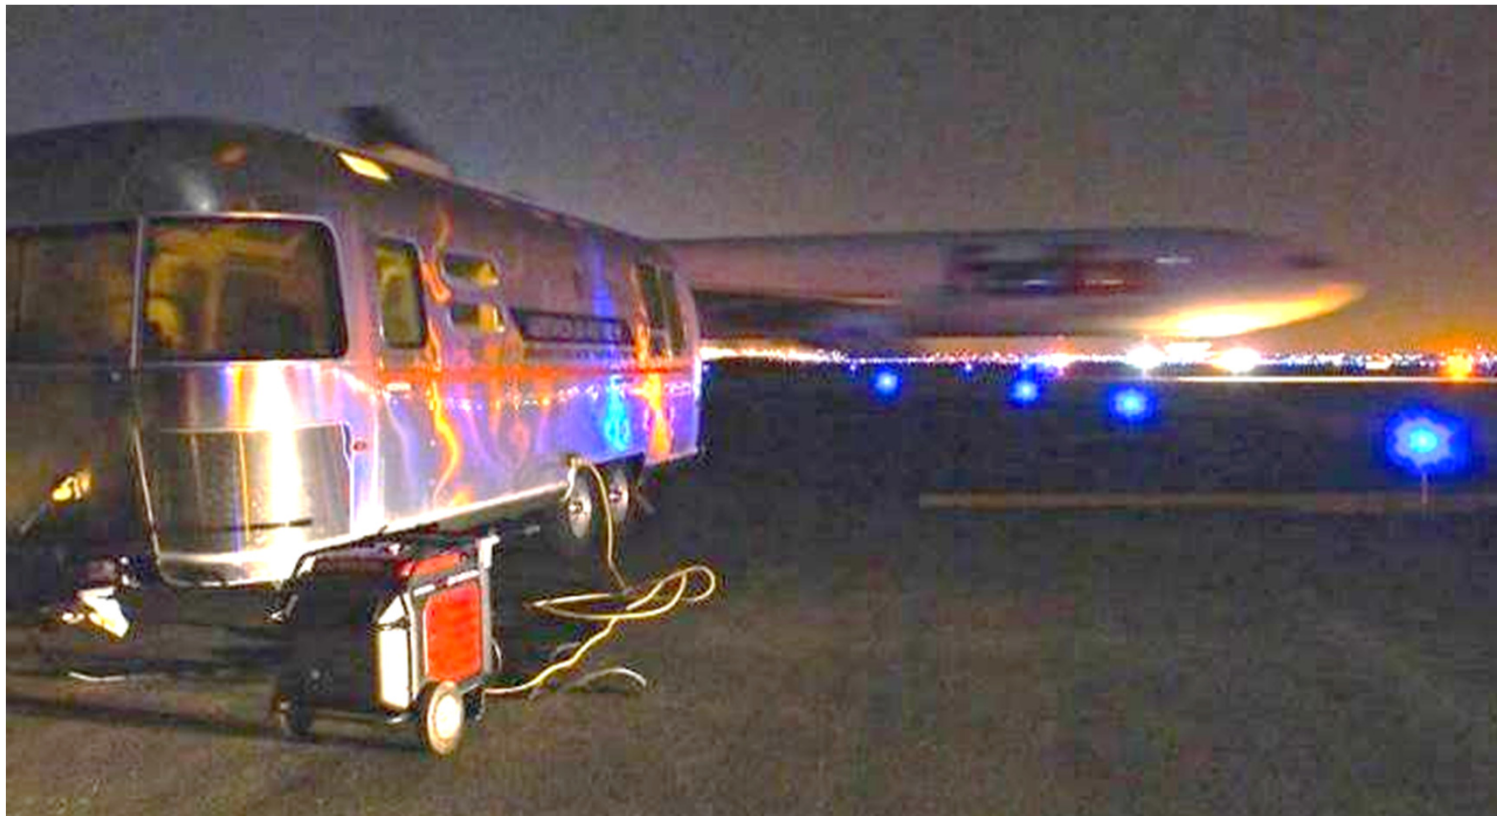
- Data recorded using UIUC Mobile Research Lab
